MY15-MY17 WHIPPLE SUPERCHARGERS BILLET THROTTLE BODY ADJUSTMENT FORD \$550/F150 5.0L

Due to factory variances on the electronic throttle cover, some adjustment may be required.

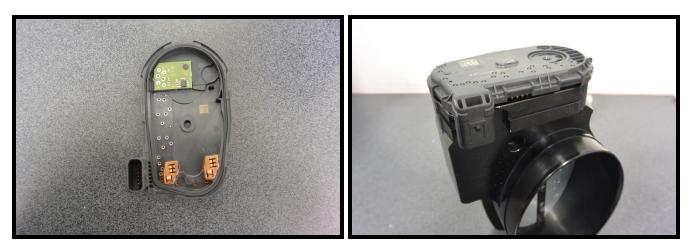
2. Remove the factory cover from the throttle body.

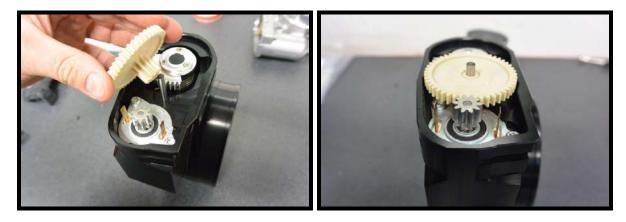
3. Remove the factory plastic gear from the throttle body by lifting up and away to access to the magnet and the (3) socket head allen bolts securing it.

4. Make a mark using a white out or grease pencil on the magnet and billet gear for reference before adjustment. Using a 2.5mm allen socket, carefully loosen the (3) bolts and remove the black magnet and magnet retainer. Carefully move the black magnet clockwise to increase voltage, counter clockwise to lower (extremely small adjustments). Lightly tighten the bolts after adjusting, install the cover without tabs, push the blade to max closed position for accurate reading and recheck TPS2 (most important reading). Repeat until the unit is in the (.40v - .045v) range at max closed position (applying light force on blade to close to zero position/max closed).

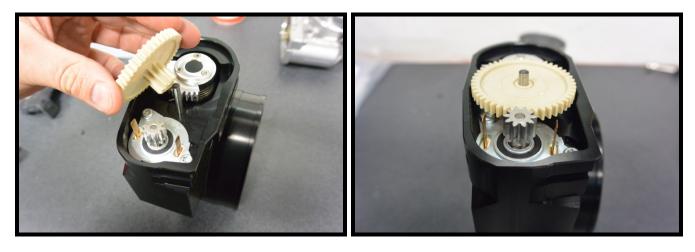
5. Reinstall the cream-colored factory gear to the throttle body by lowering onto the pressed in shaft. Move until it falls into place.

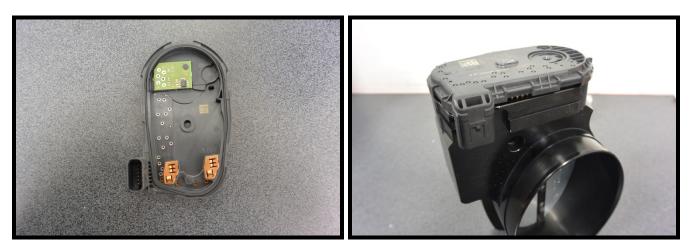
6. Reinstall the factory cover, make sure the oring stays in place during assembly and the (2) electrical connections are made.

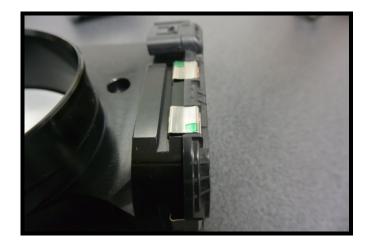
7. Reuse the (6) throttle body cover tabs by pressing on until they click and lock in place.
